FHWA- INVESTIGATION OF THE EFFECTIVENESS OF EXISTING
RD- GE DESIGN METHODOLOGY IN PROVIDING ADEQUATE
73-13 STRUCTURAL RESISTANCE TO SEISMIC DISTURBANCES.

Phase I: Literature Survey

T. Iwasaki, J. Penzien, and R. Clough

November 1972
Final Report

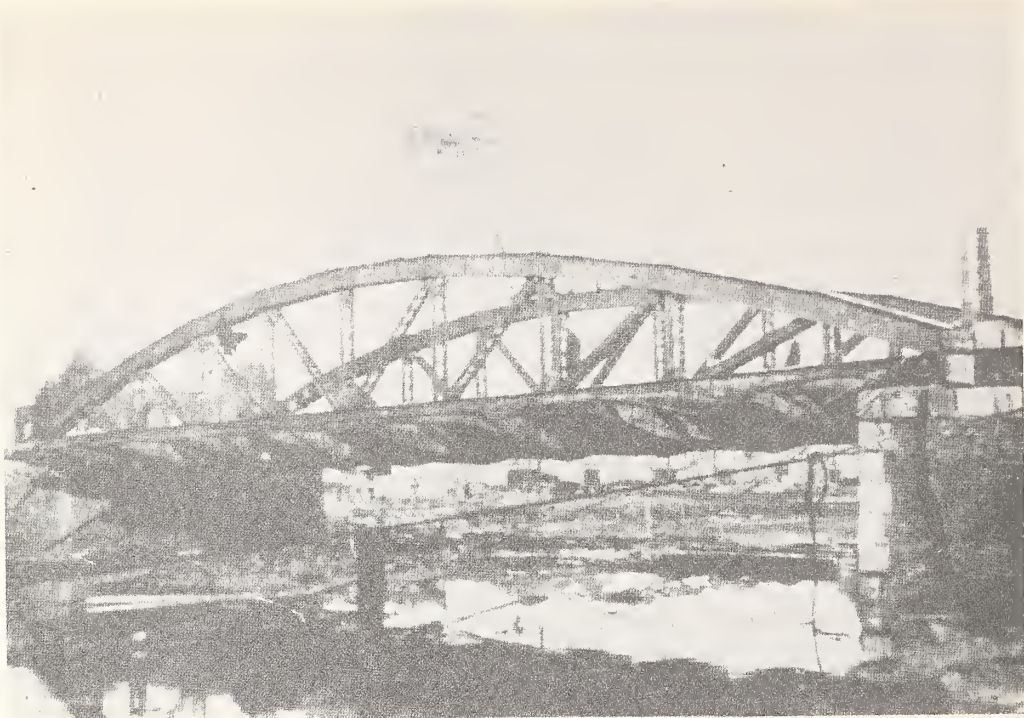
Photo. 2.3 Damage to the Bankoku bridge
(note heavy cracks at the abutment)

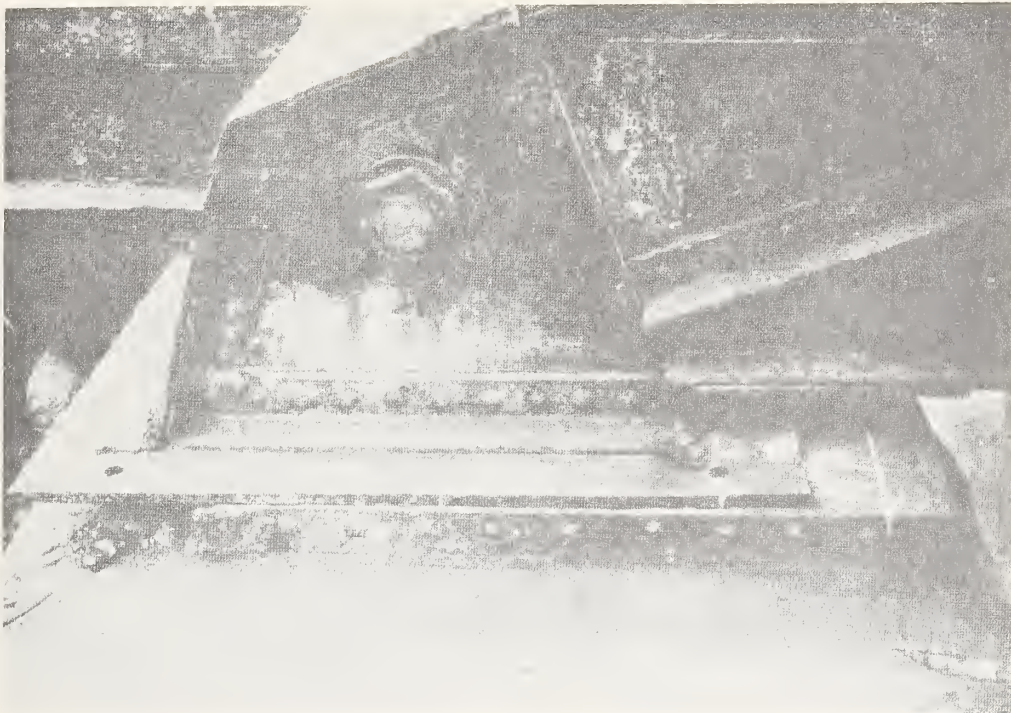
Photo. 2.5 Damage to the east support at the southern abutment of the Bankoku bridge (note anchor bolts sheared off).

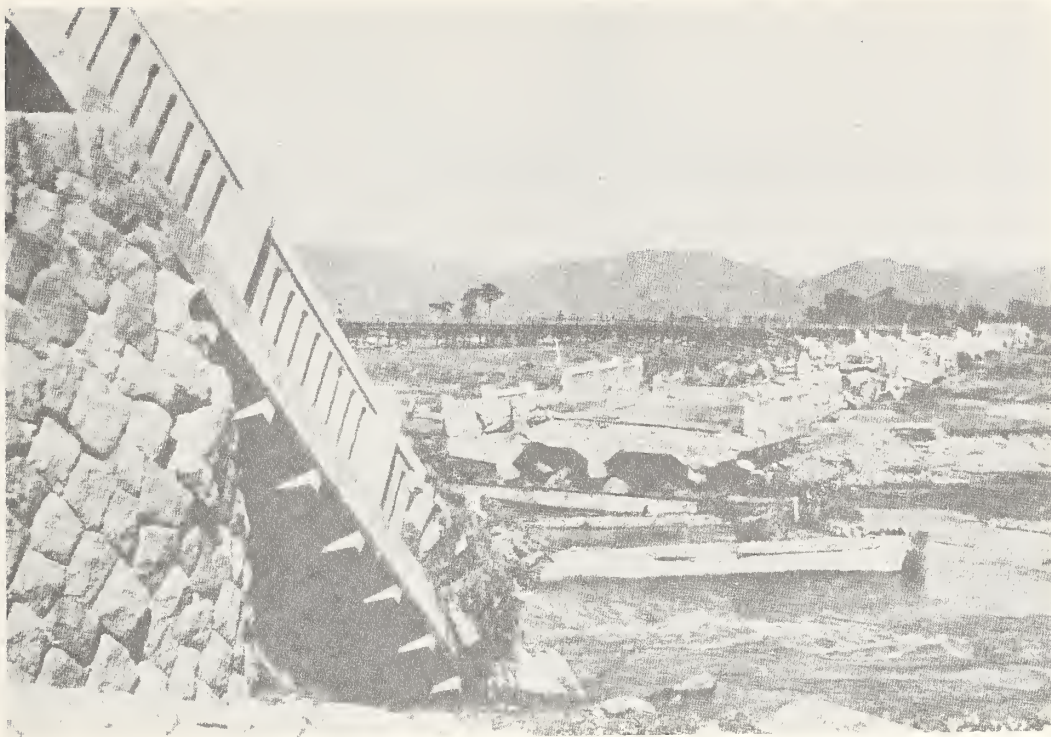
Photo. 2.9 Damage to the Sakawa bridge

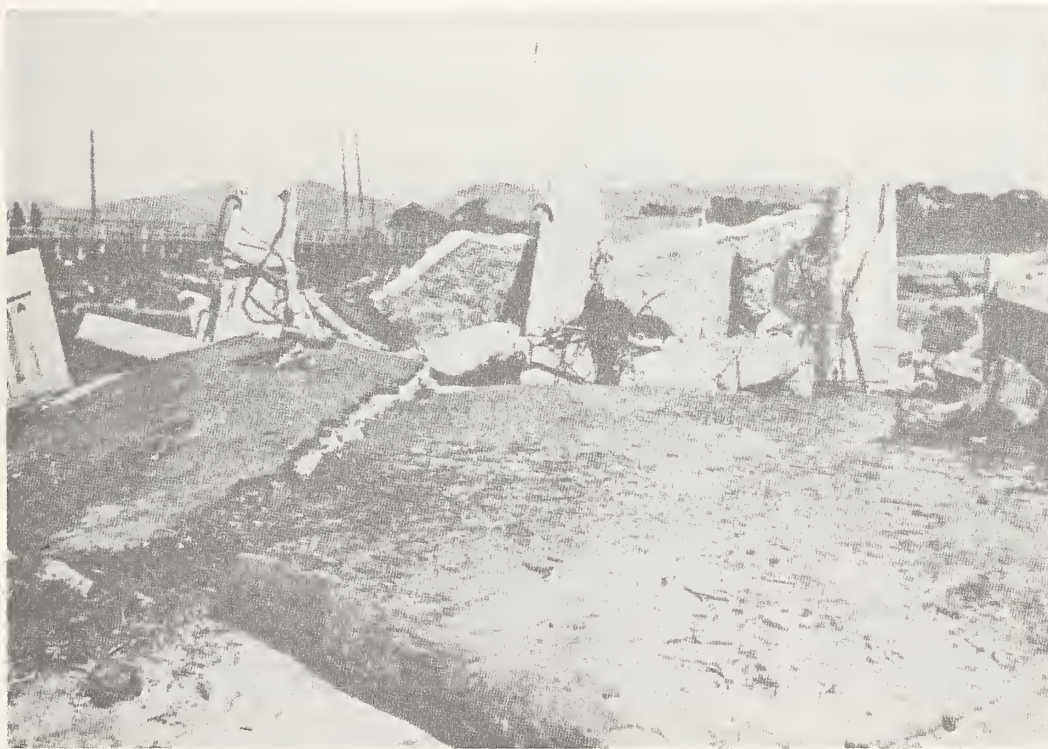
Photo. 2.10 Damaged piers and girders of the Sakawa bridge

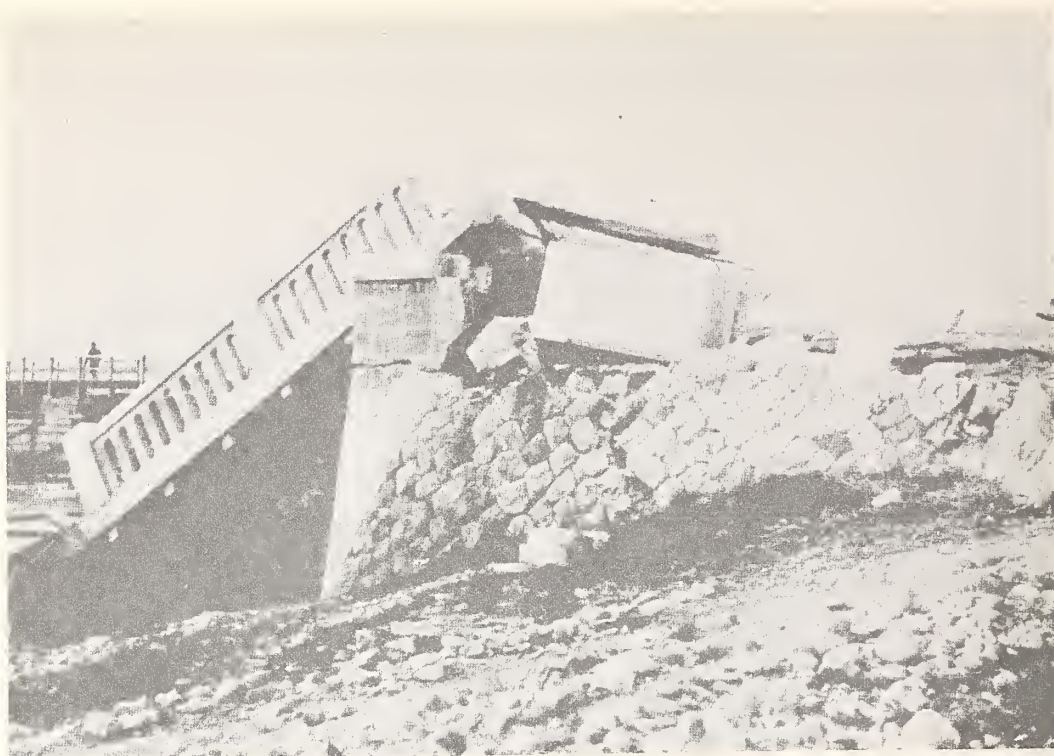
Photo. 2.11 Damage to the left abutment of the Sakawa bridge

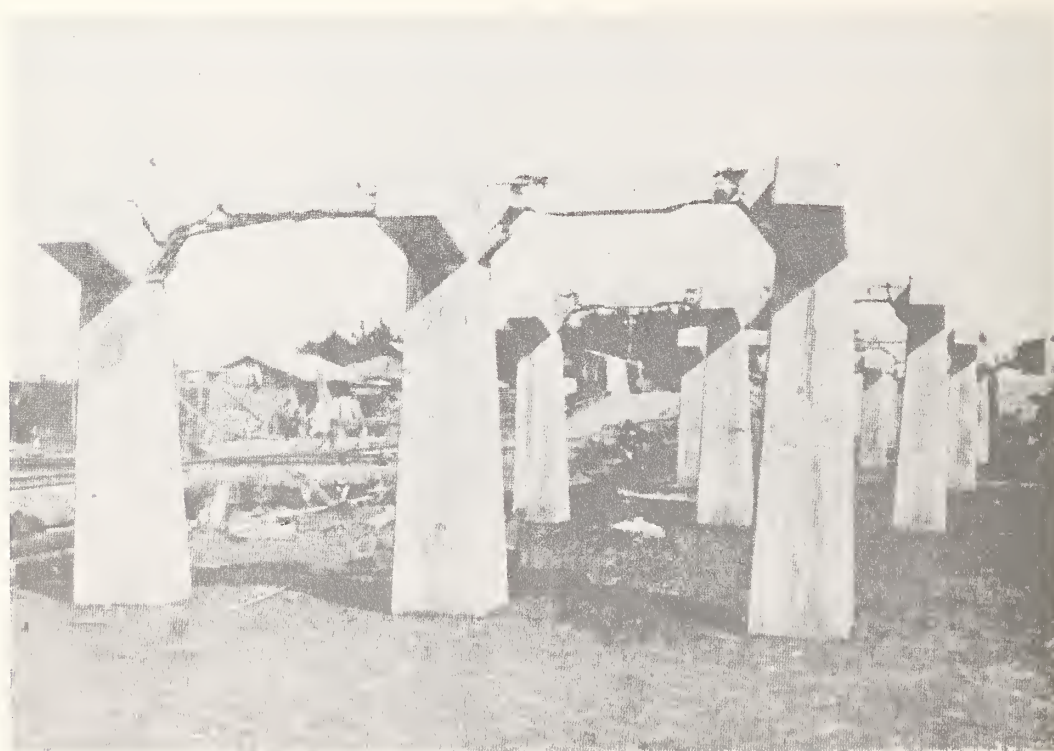
Photo. 2.12 Damage to the piers of the Banyu bridge while under construction.

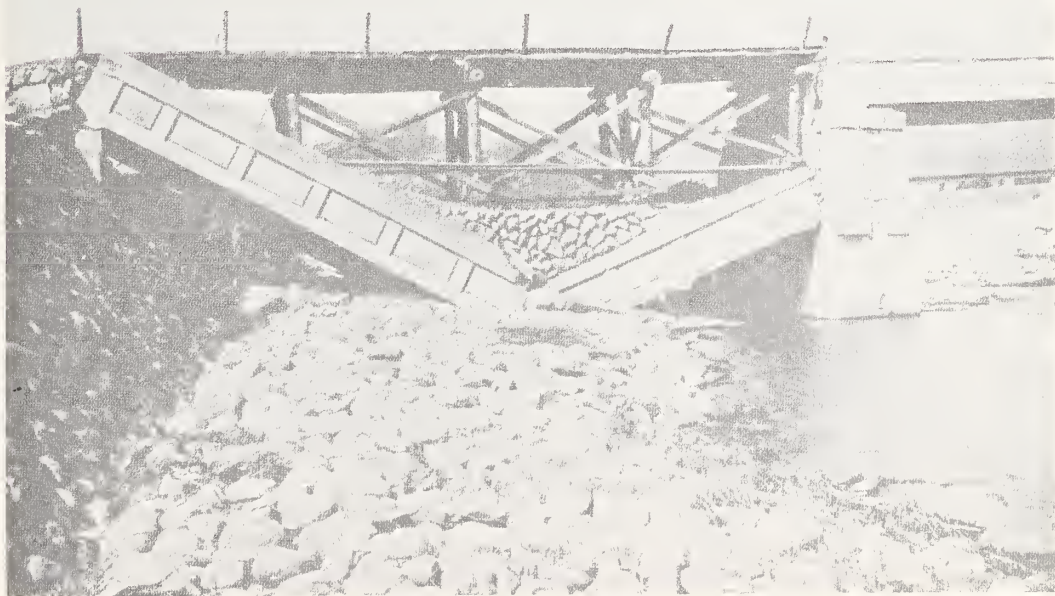
Photo.2.14 Damage to the Hayakawa bridge

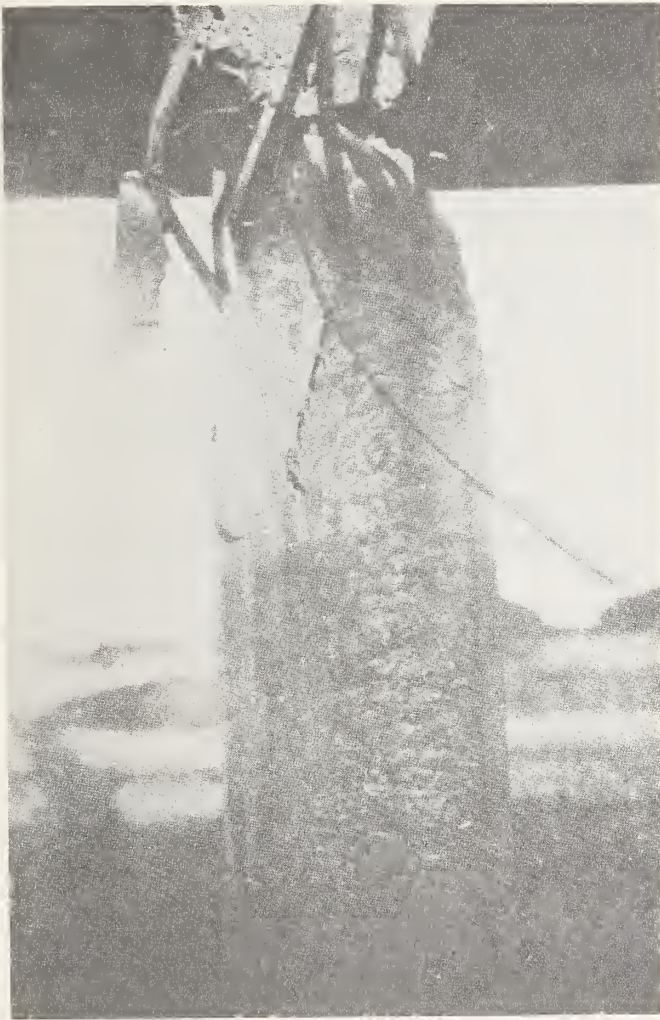
Photo.2.17 Damage to the fifth pier of the Takahata bridge.

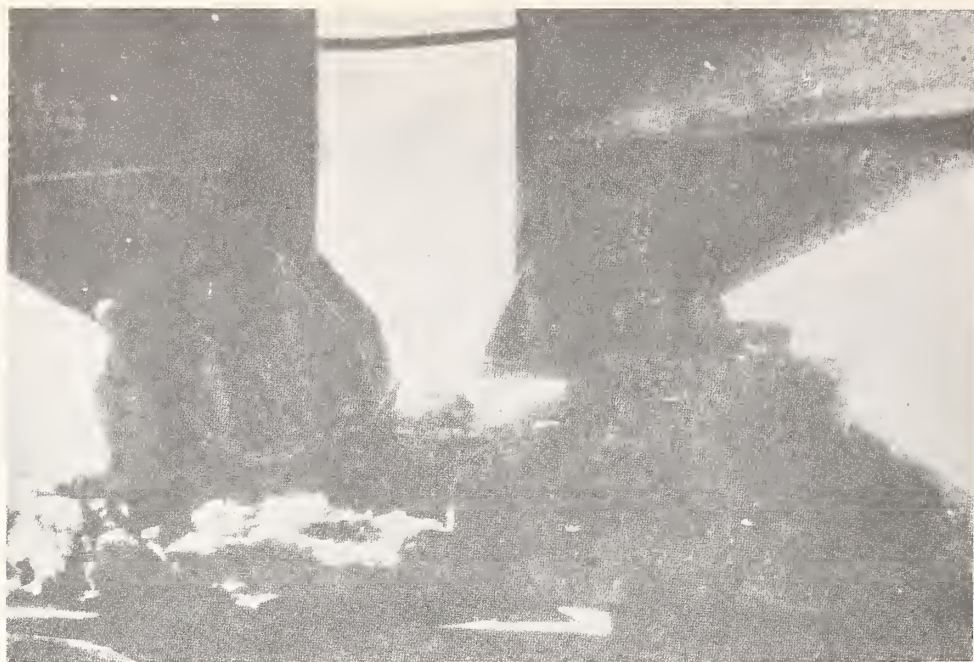
Photo.2.19 Damage to the support shoes of the Kumano bridge

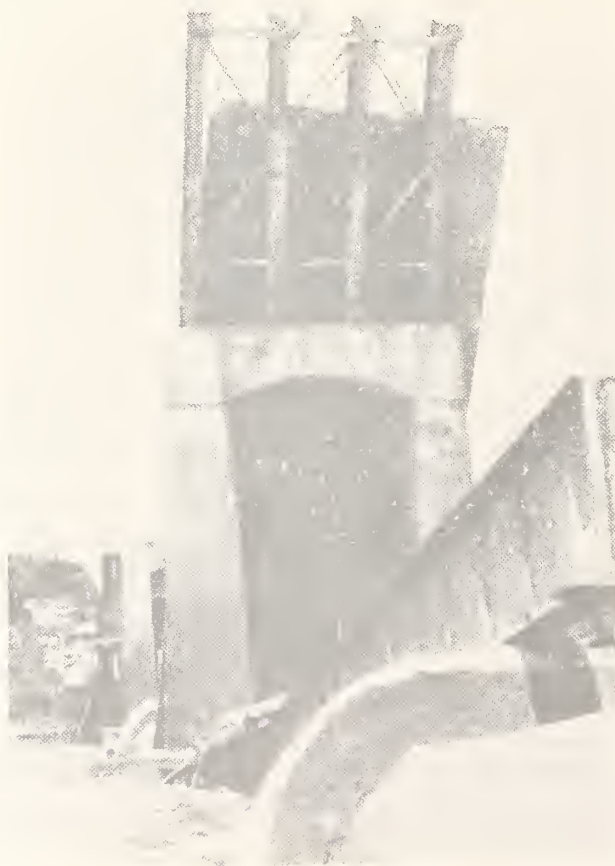
Photo.2.24 Damage to the girders of the Nakazuno bridge

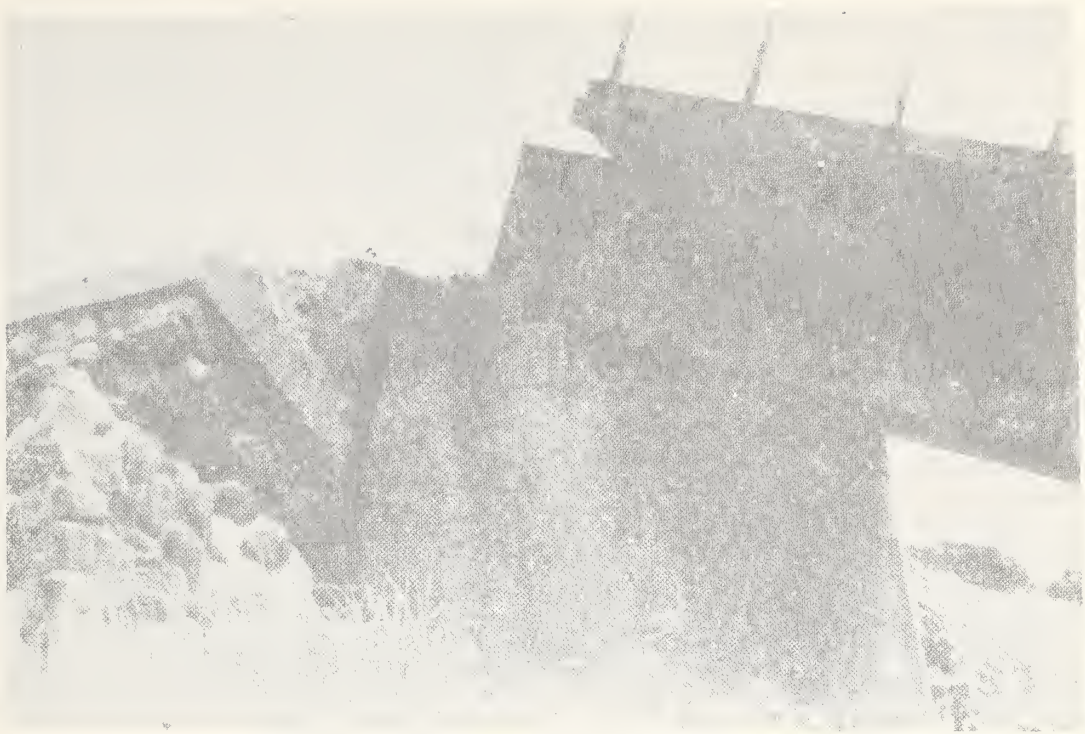
Photo.2.25 Damage to the left abutment
of the Nakazuno bridge

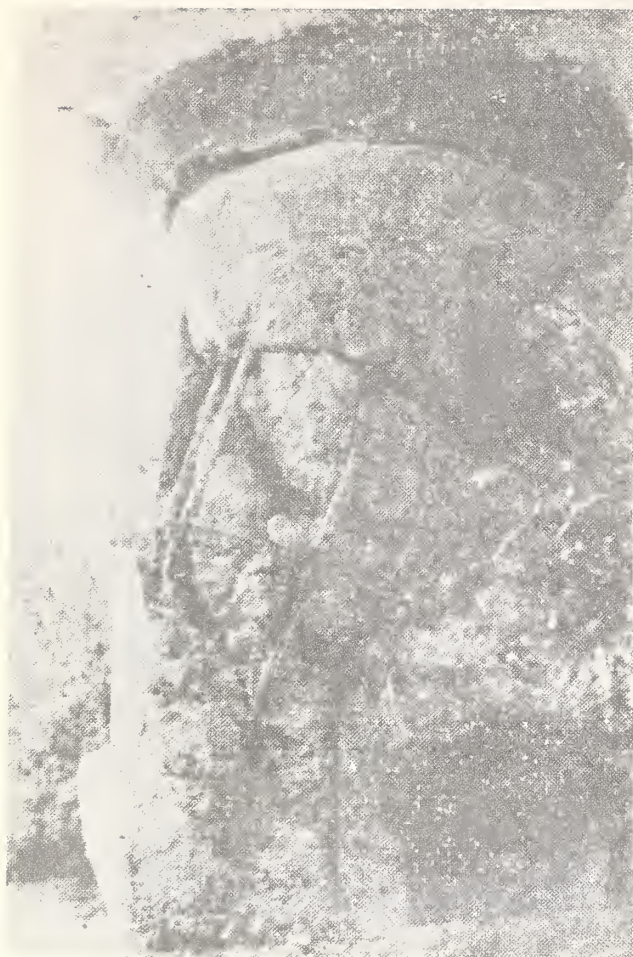
Photo.2.35 Damage to a
column of the
Koroba bridge

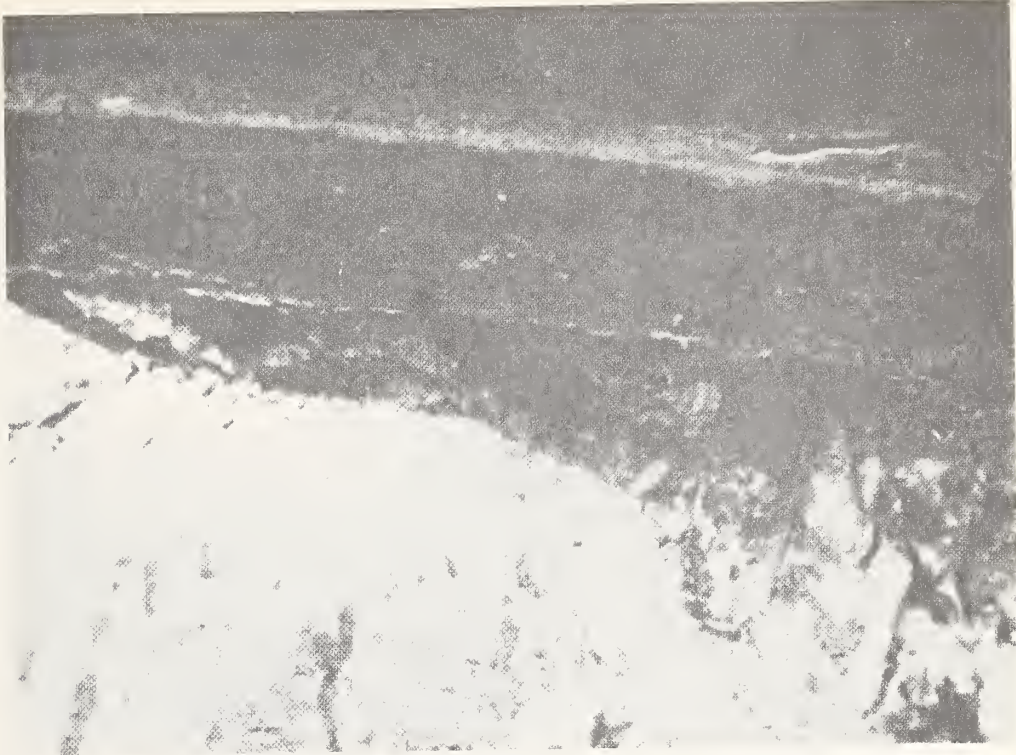
Photo.2.37 Damage to the support shoe at a pier
of the Shizunai bridge

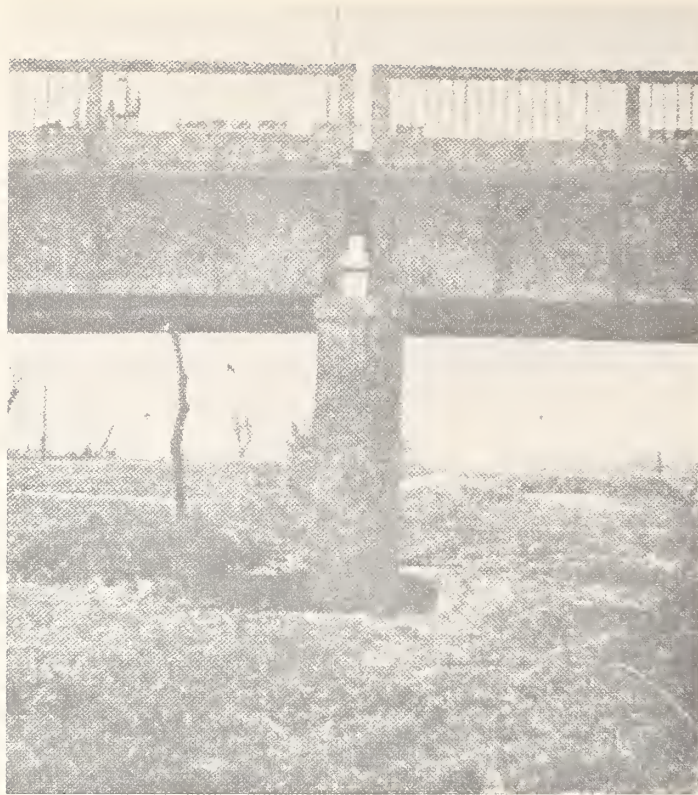
Photo. 2.39 Damage to the
girders of the Eai bridge at
a supporting pier

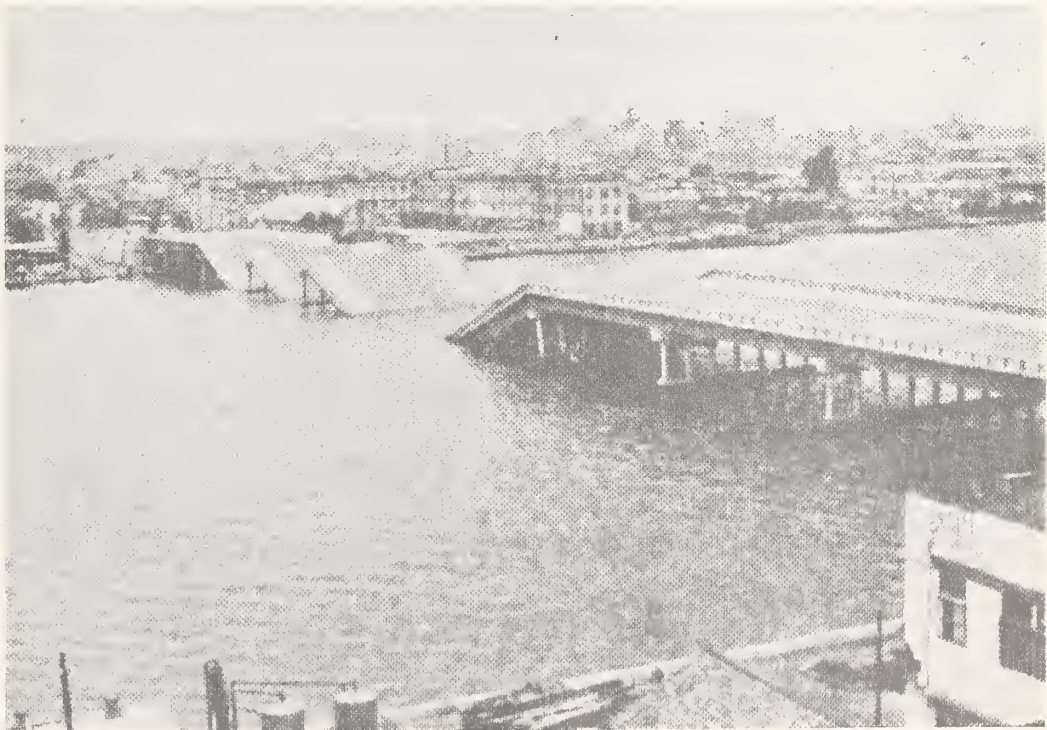
Photo.2.42 Damage to the Showa bridge

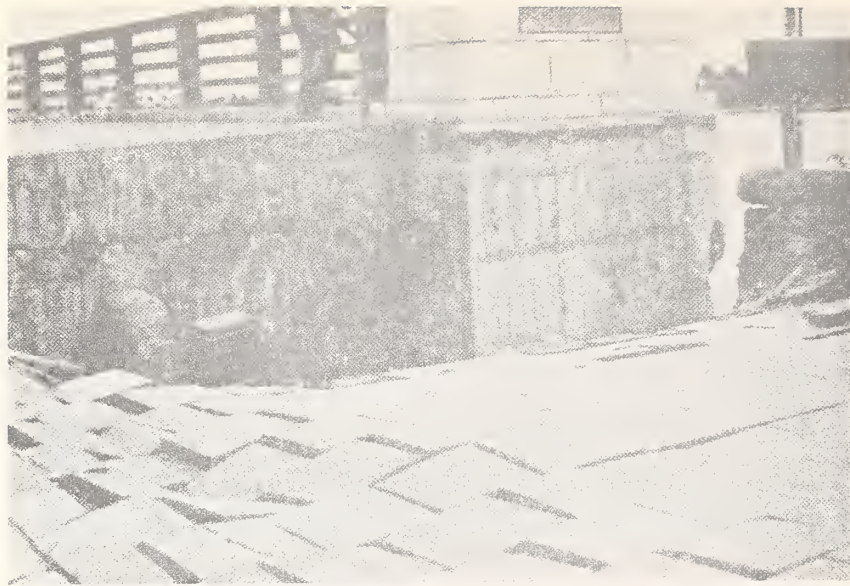
Photo. 2.43 Damage to the Showa bridge (settlement of the approach road at the left-bank abutment).

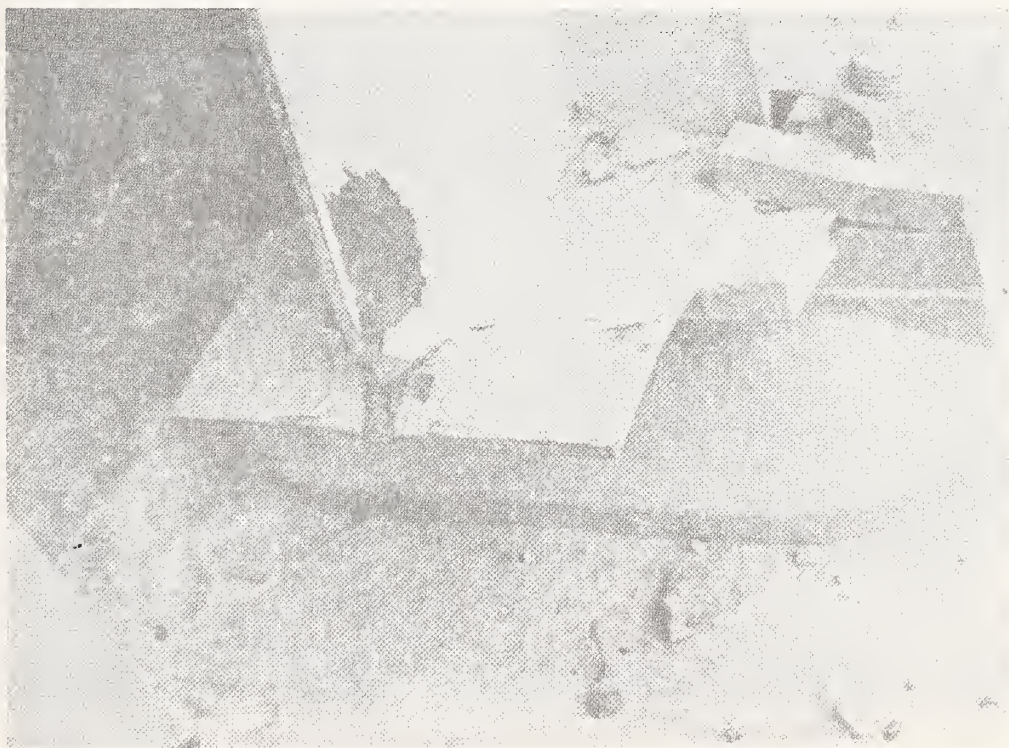
Photo. 2.46 Damage to the third girder at the second pier of the Showa bridge.

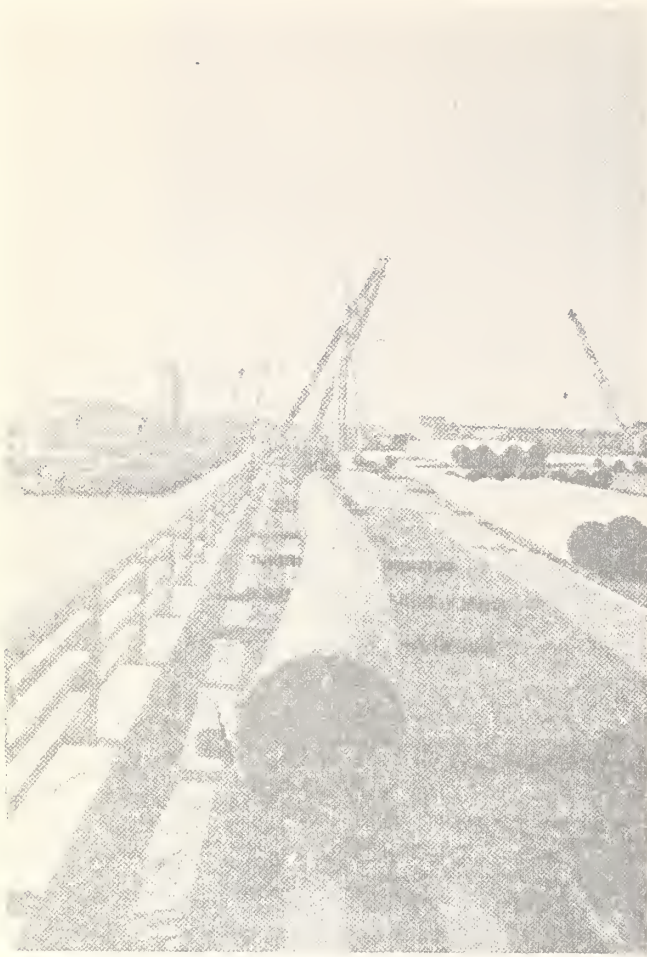
Photo. 2.47 Damage to a pulled-out pile at the fourth pier of the Showa bridge.

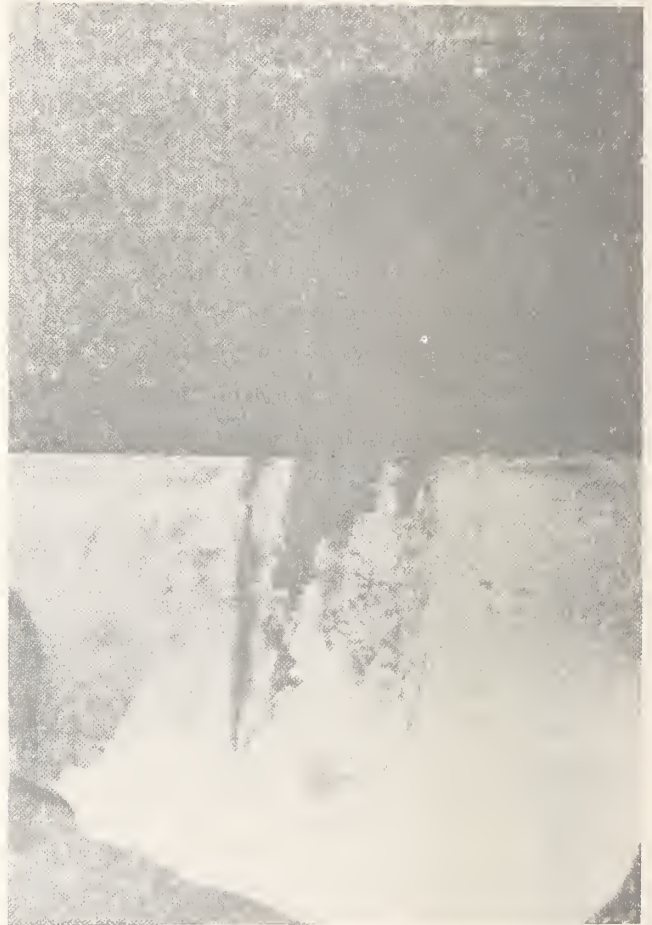
Photo. 2.48 Buckling feature of the pile shown in Photo 2.47.

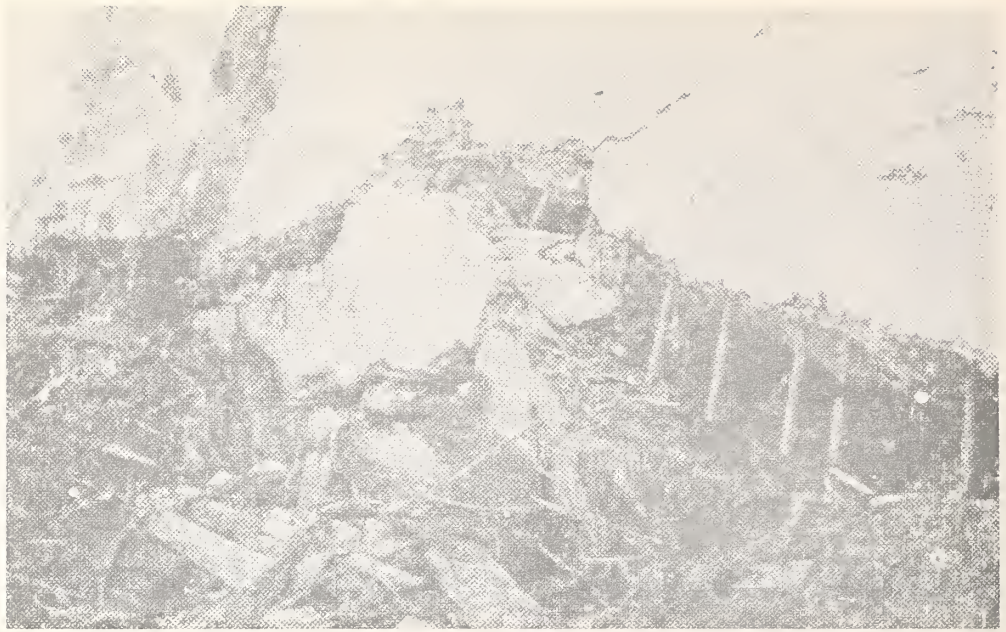
Photo.2.51 Damage to the second pier
 of the Yachiyo bridge

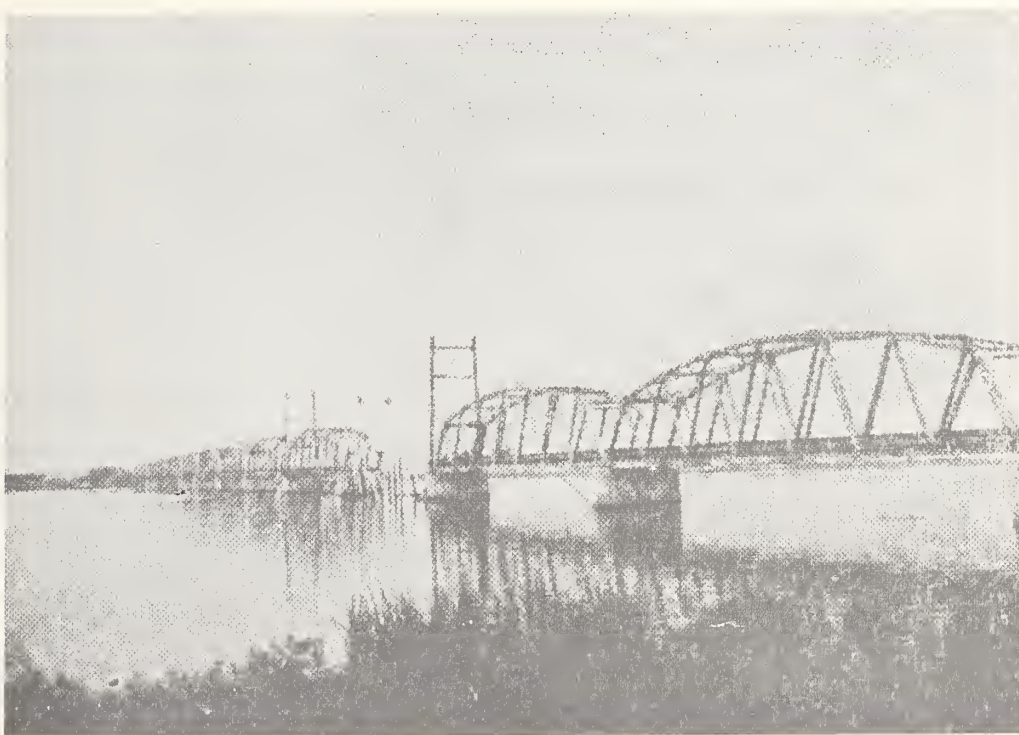
Photo. 2.58 Damage to the Matsuhama bridge.

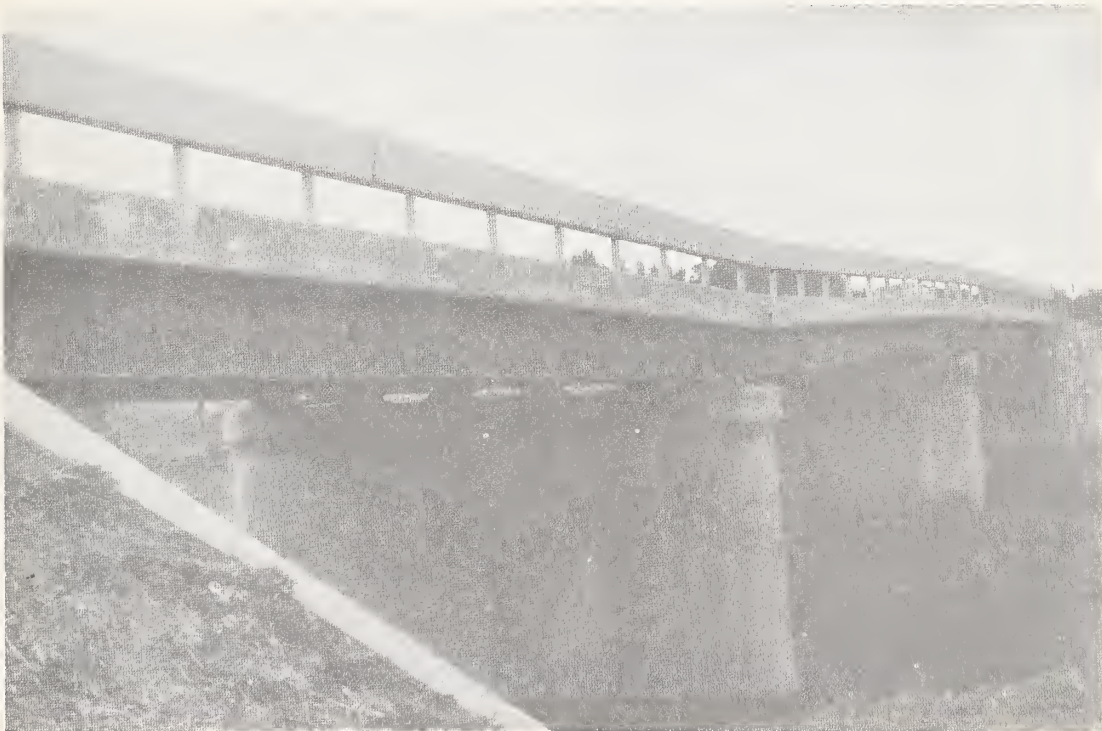
The first pier from the left bank settled about 25 cm during the earthquake (Photo 2.62). No significant damage was observed to other

Photo.2.62 Damage to the Ikejima bridge
(pier settled due to soil liquefaction)

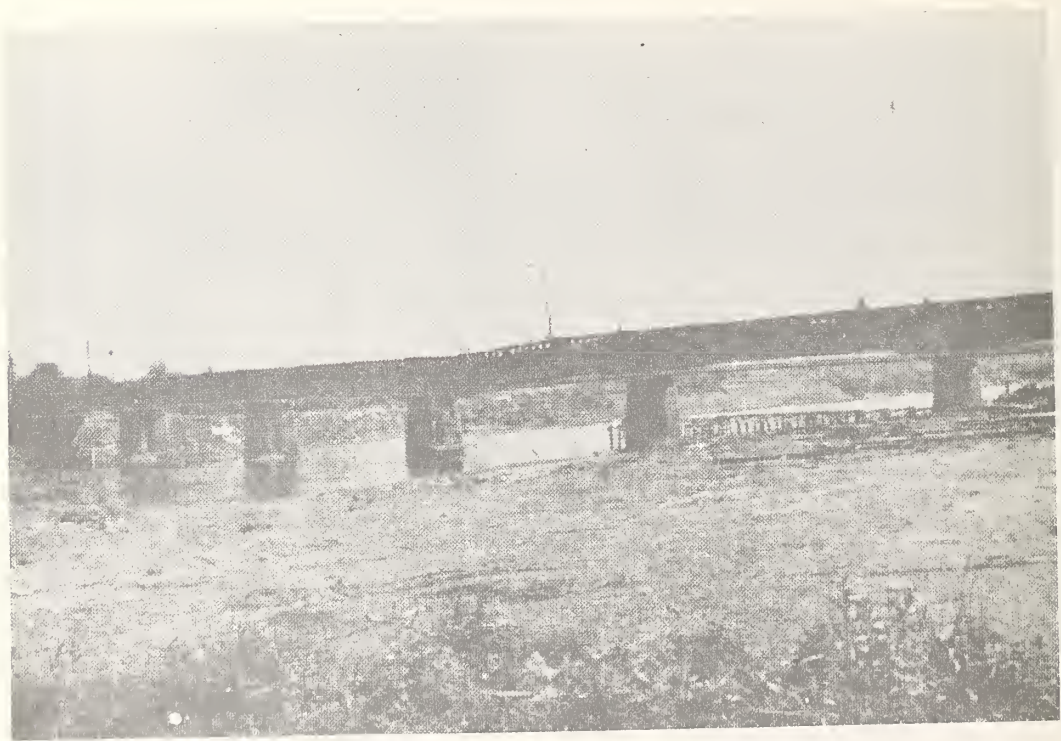
Photo.2.64 Settlement of pier at the
Shiriuchi bridge.

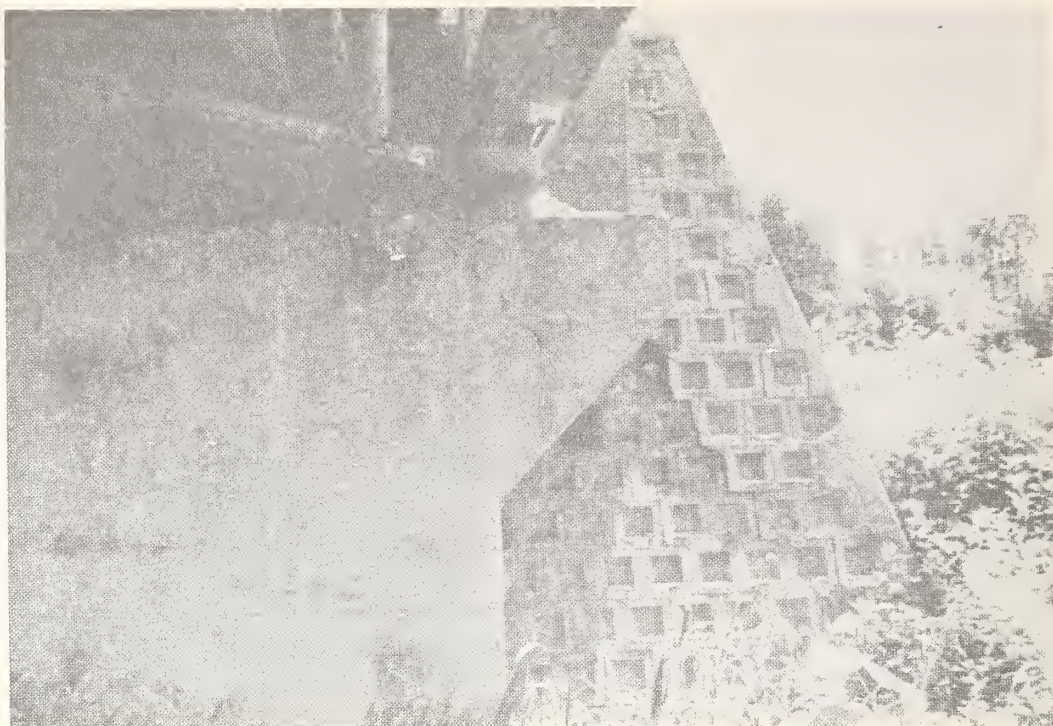
The damages to bridge structures had characteristics very much like those previously described for similar bridges during other earthquakes. Pile bent piers sustained moderate damage due to lack of stiffness (Photo 2.63) and one pier settled about 20 cm due to lack of bearing capacity in the foundation which had been scoured by the river stream (Photo 2.64). Several abutments were pushed toward the center of the river (Photo 2.65) and some abutments developed cracks in the concrete near the bearing supports (Photo 2.66, 2.67). Girders were

Photo. 2.67 Crack of abutment of the
Komagome bridge

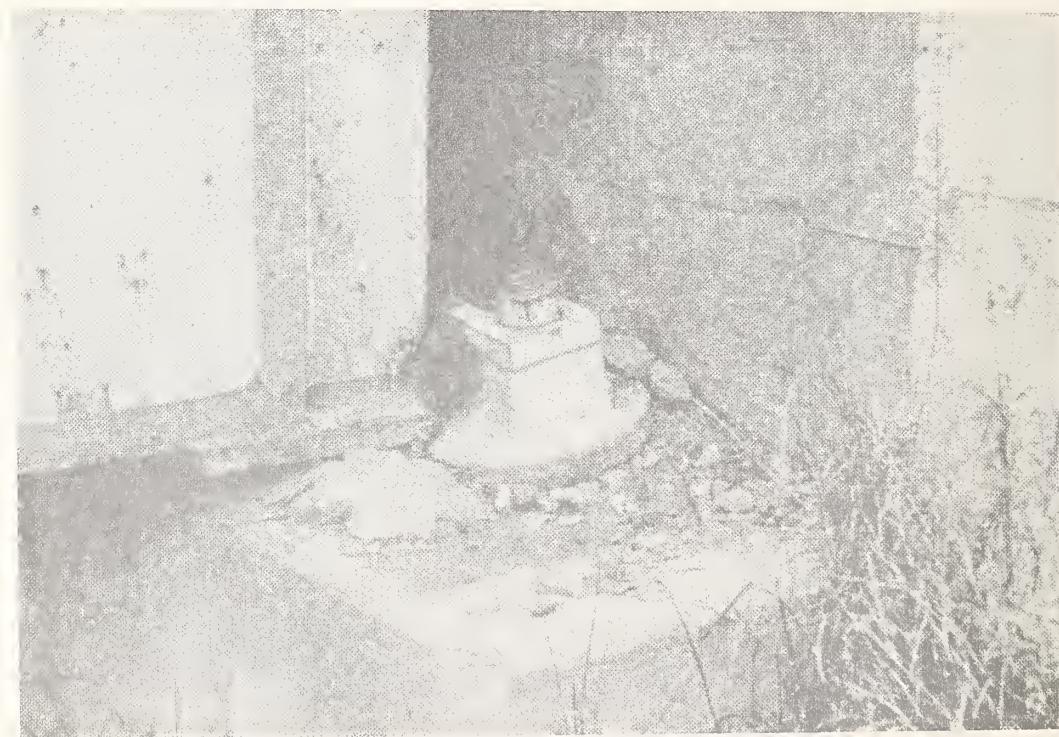
shifted slightly, and bearing supports sustained moderate damage including failure of the concrete (Photo 2.68). The ends of the girders of one reinforced concrete bridge collided causing significant crushing (Photo 2.69). Settlements of the approach roads amounting to a few decimeters were observed. These settlements were apparently caused by compaction of the fill during the earthquake.

Photo. 2.68 Damage to the support shoe of the
Kaimei bridge.

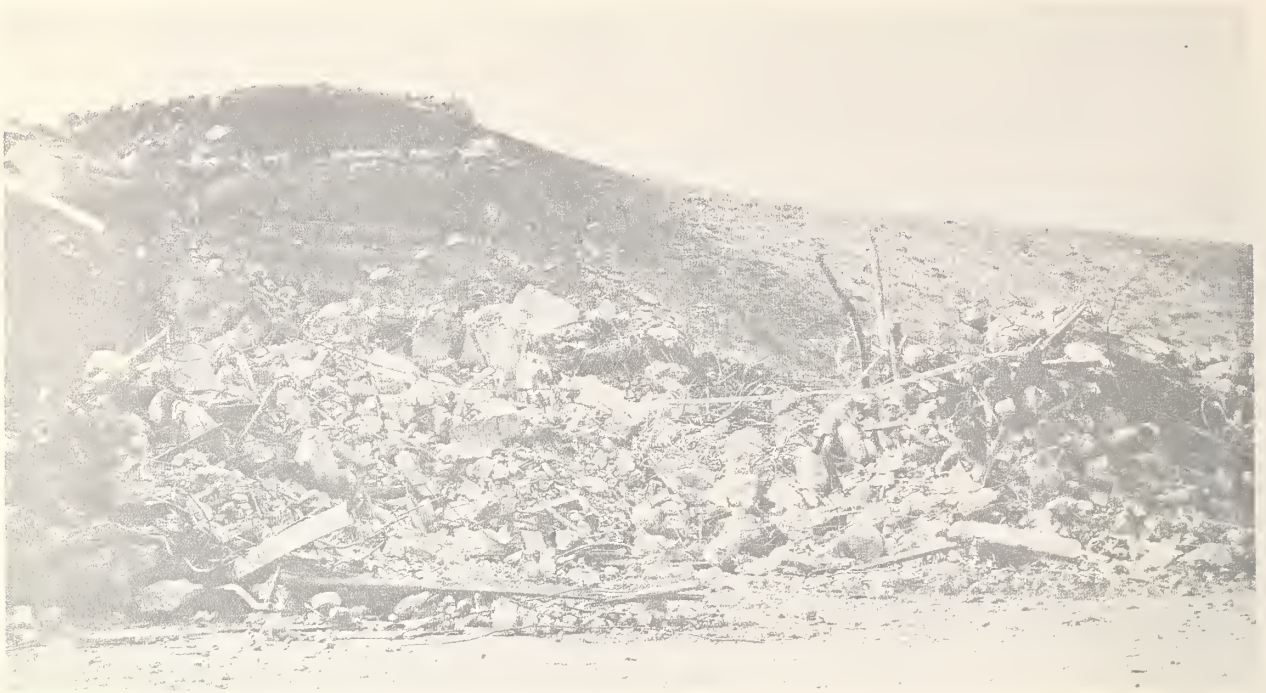
Photo. 2.71 South abutment of overcrossing at Golden State Freeway and Foothill Freeway interchange

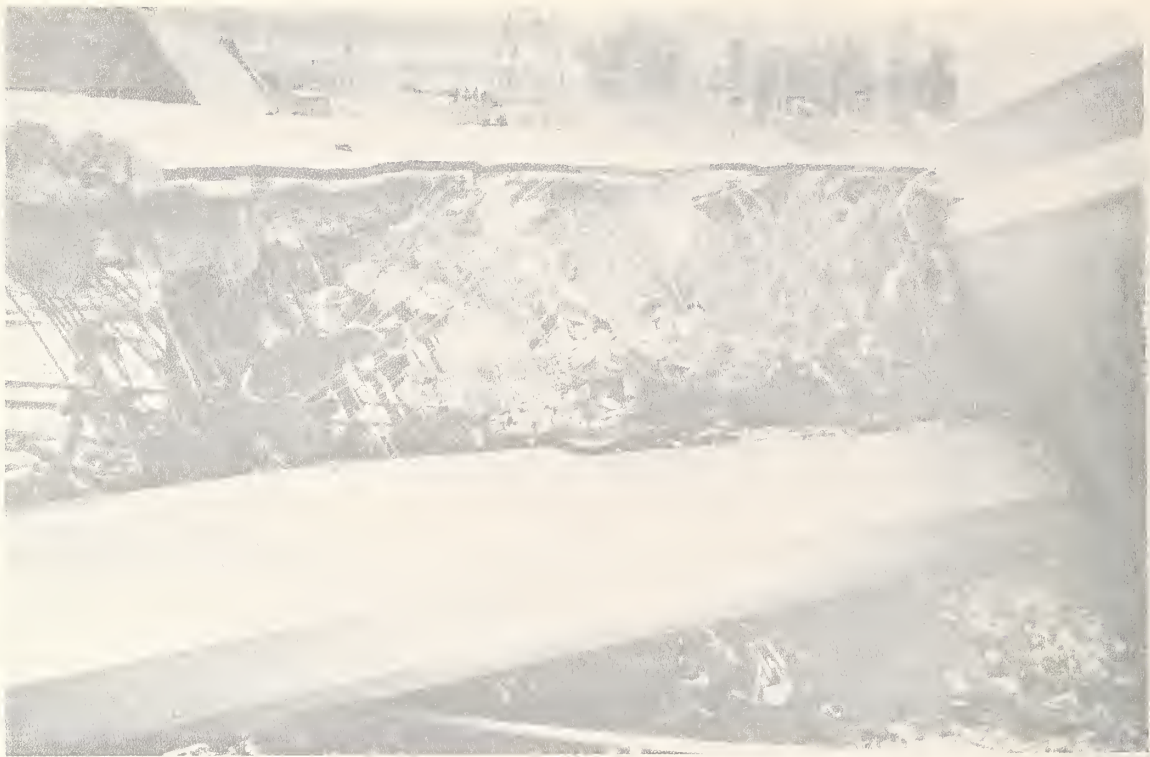
Photo. 2.95 Column of overcrossing at Golden State Freeway and Foothill Freeway interchange

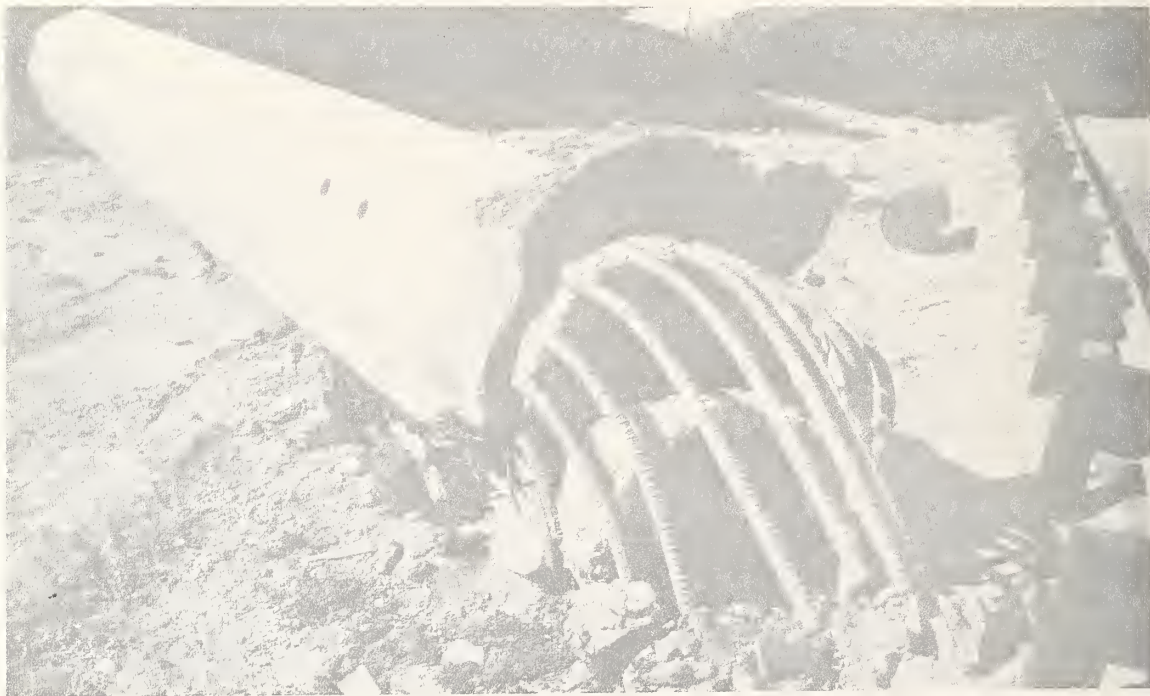
Photo. 2.96 Failure at base of column supported on a single 6 foot diameter cast-in-drilled-hole pile - Golden State Freeway and Foothill Freeway interchange

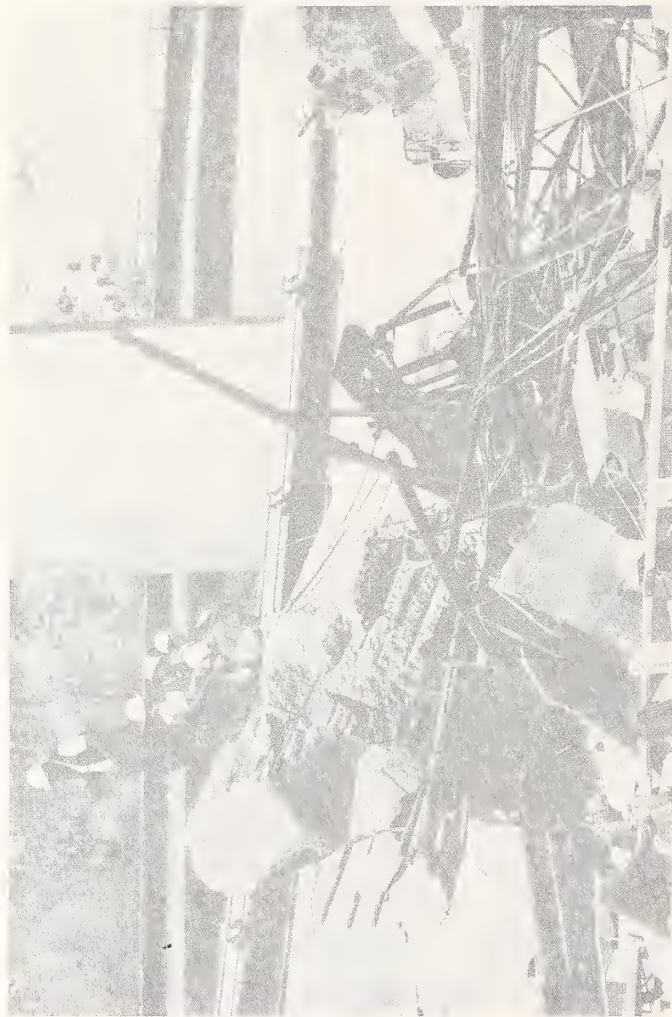
Photo. 2.107 Crane truck crushed by column - Golden State Freeway and State Highway 14 interchange

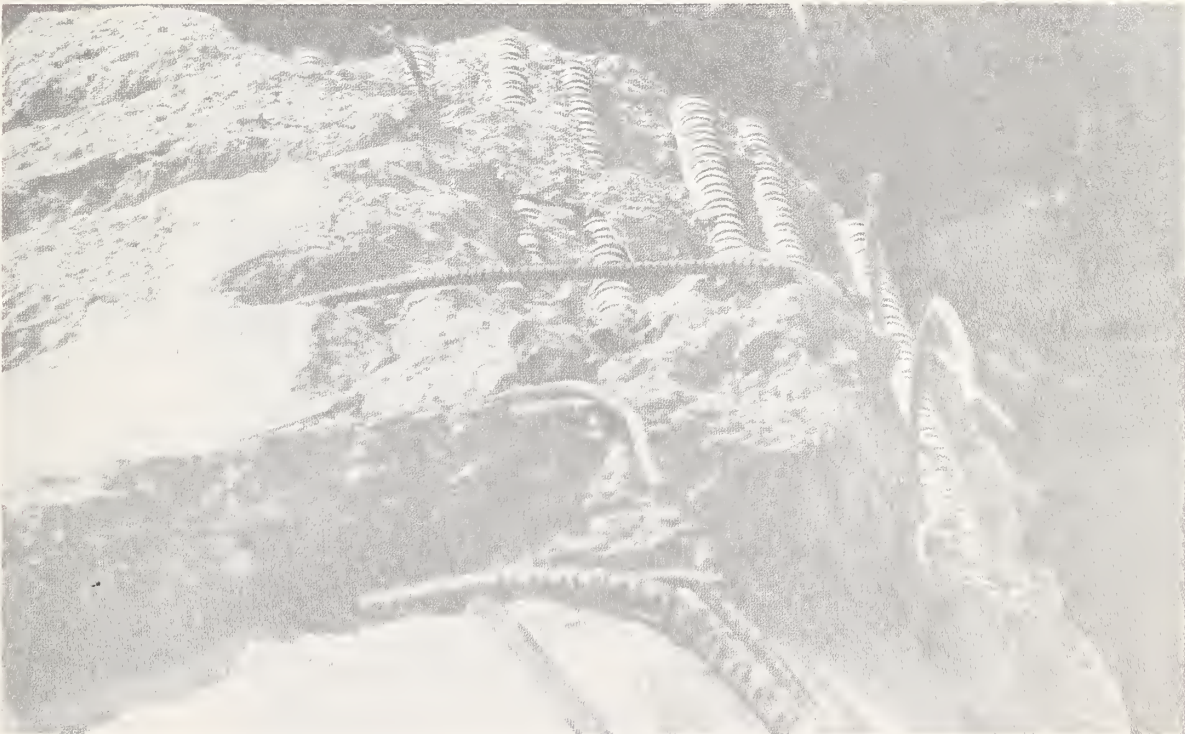
Photo. 2.110 Top end of collapsed column of overcrossing at Golden State Freeway and State Highway 14 interchange

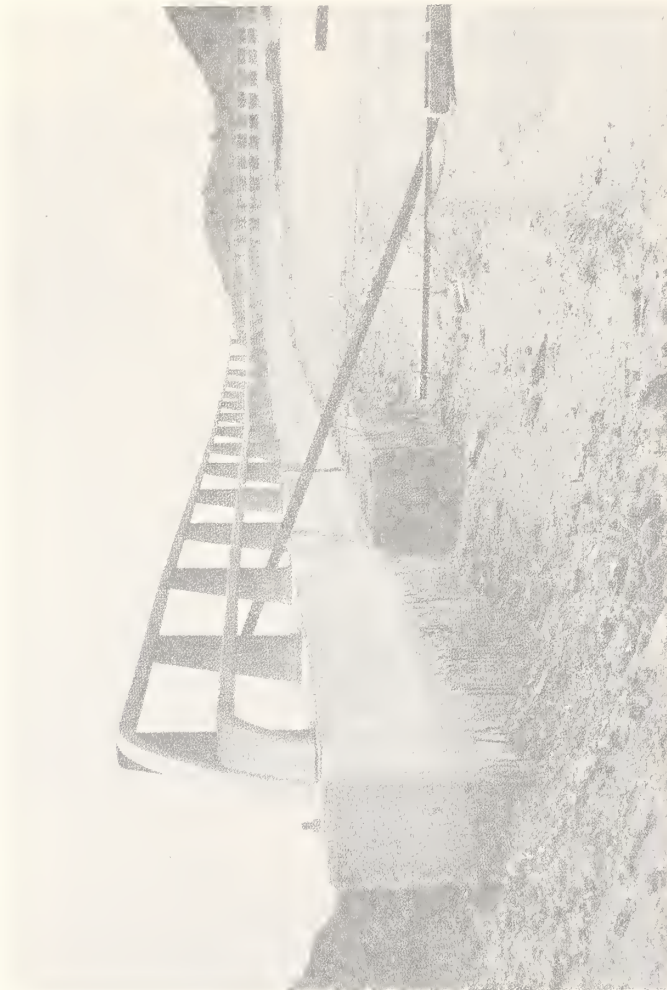
Photo. 2.111 Settlement of backfill at abutment of overcrossing - Golden State Freeway and State Highway 14 interchange
